Debris/Ice/TPS Assessment And Integrated Photographic Analysis For Shuttle Mission STS-49

July 1992

Shuttle Mission STS-49 was launched at 7:40 p.m. local 5/7/92

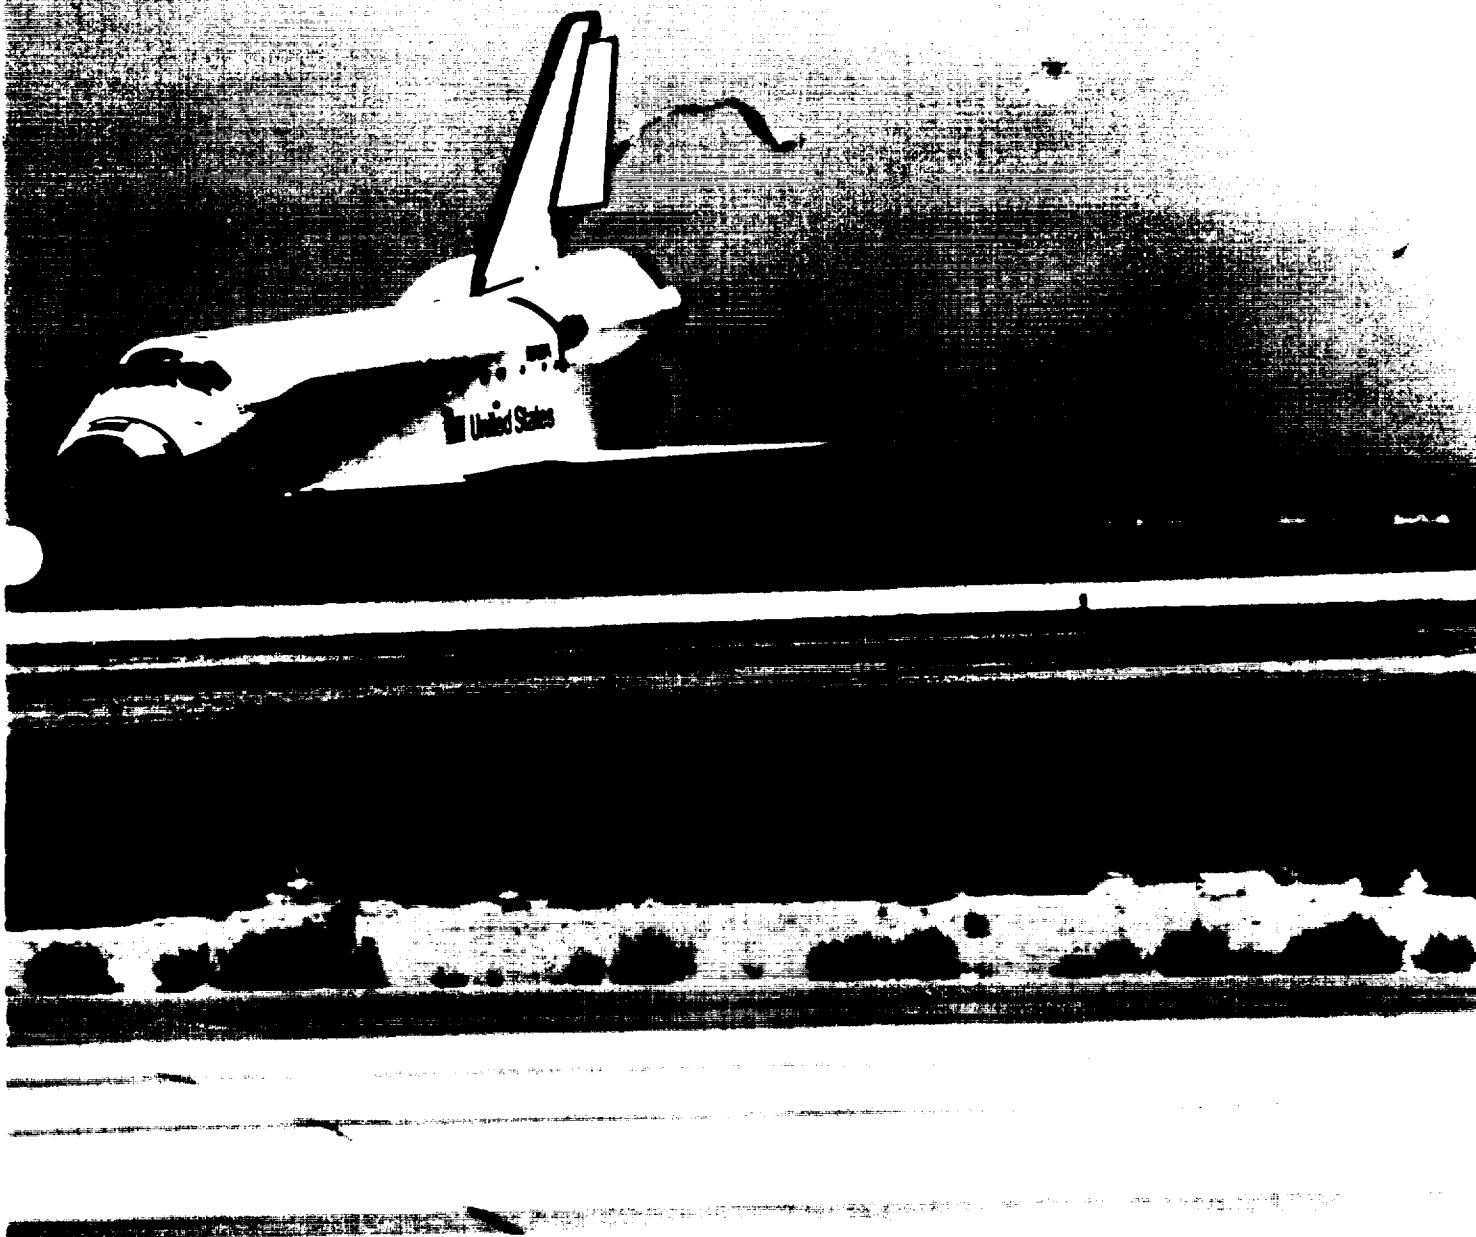
This flight marked the first use of the Orbiter drag chute, which functioned normally. The drag chute compartment door and the sabot/pilot chute bag are visible at the right side of the frame.

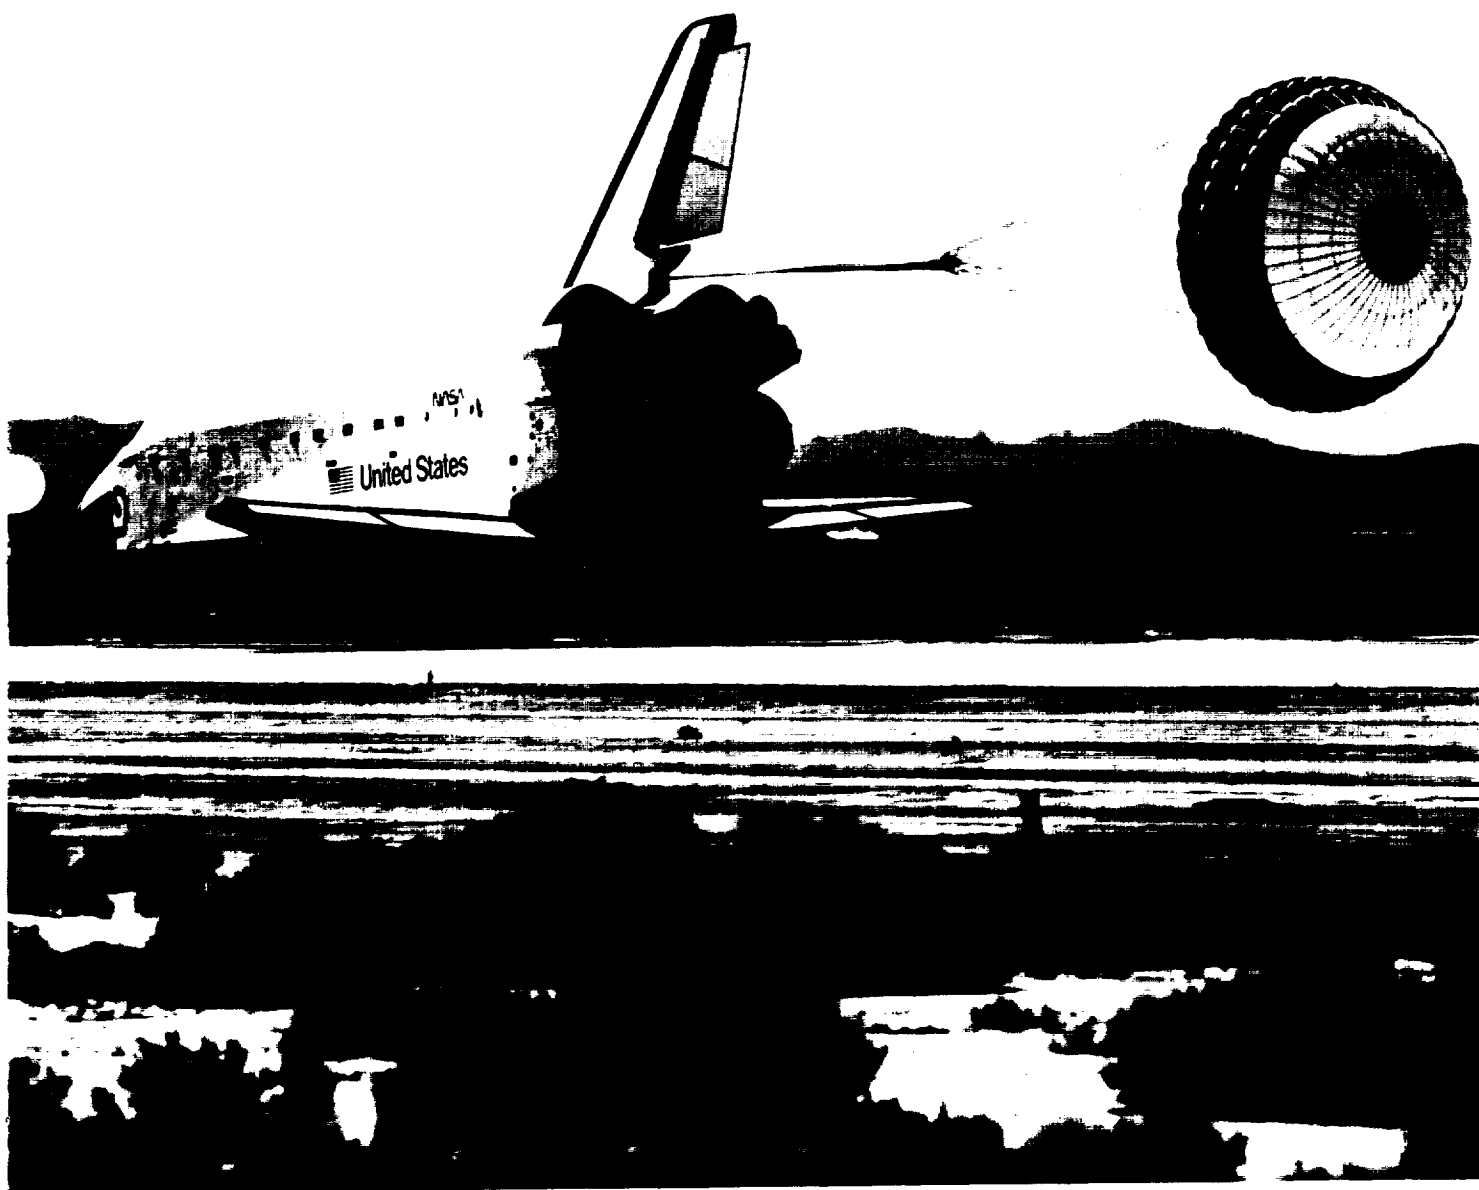
Deployment of the drag chute was nominal. The risers did not contact the SSME #1 nozzle or the rudder/speed brake.

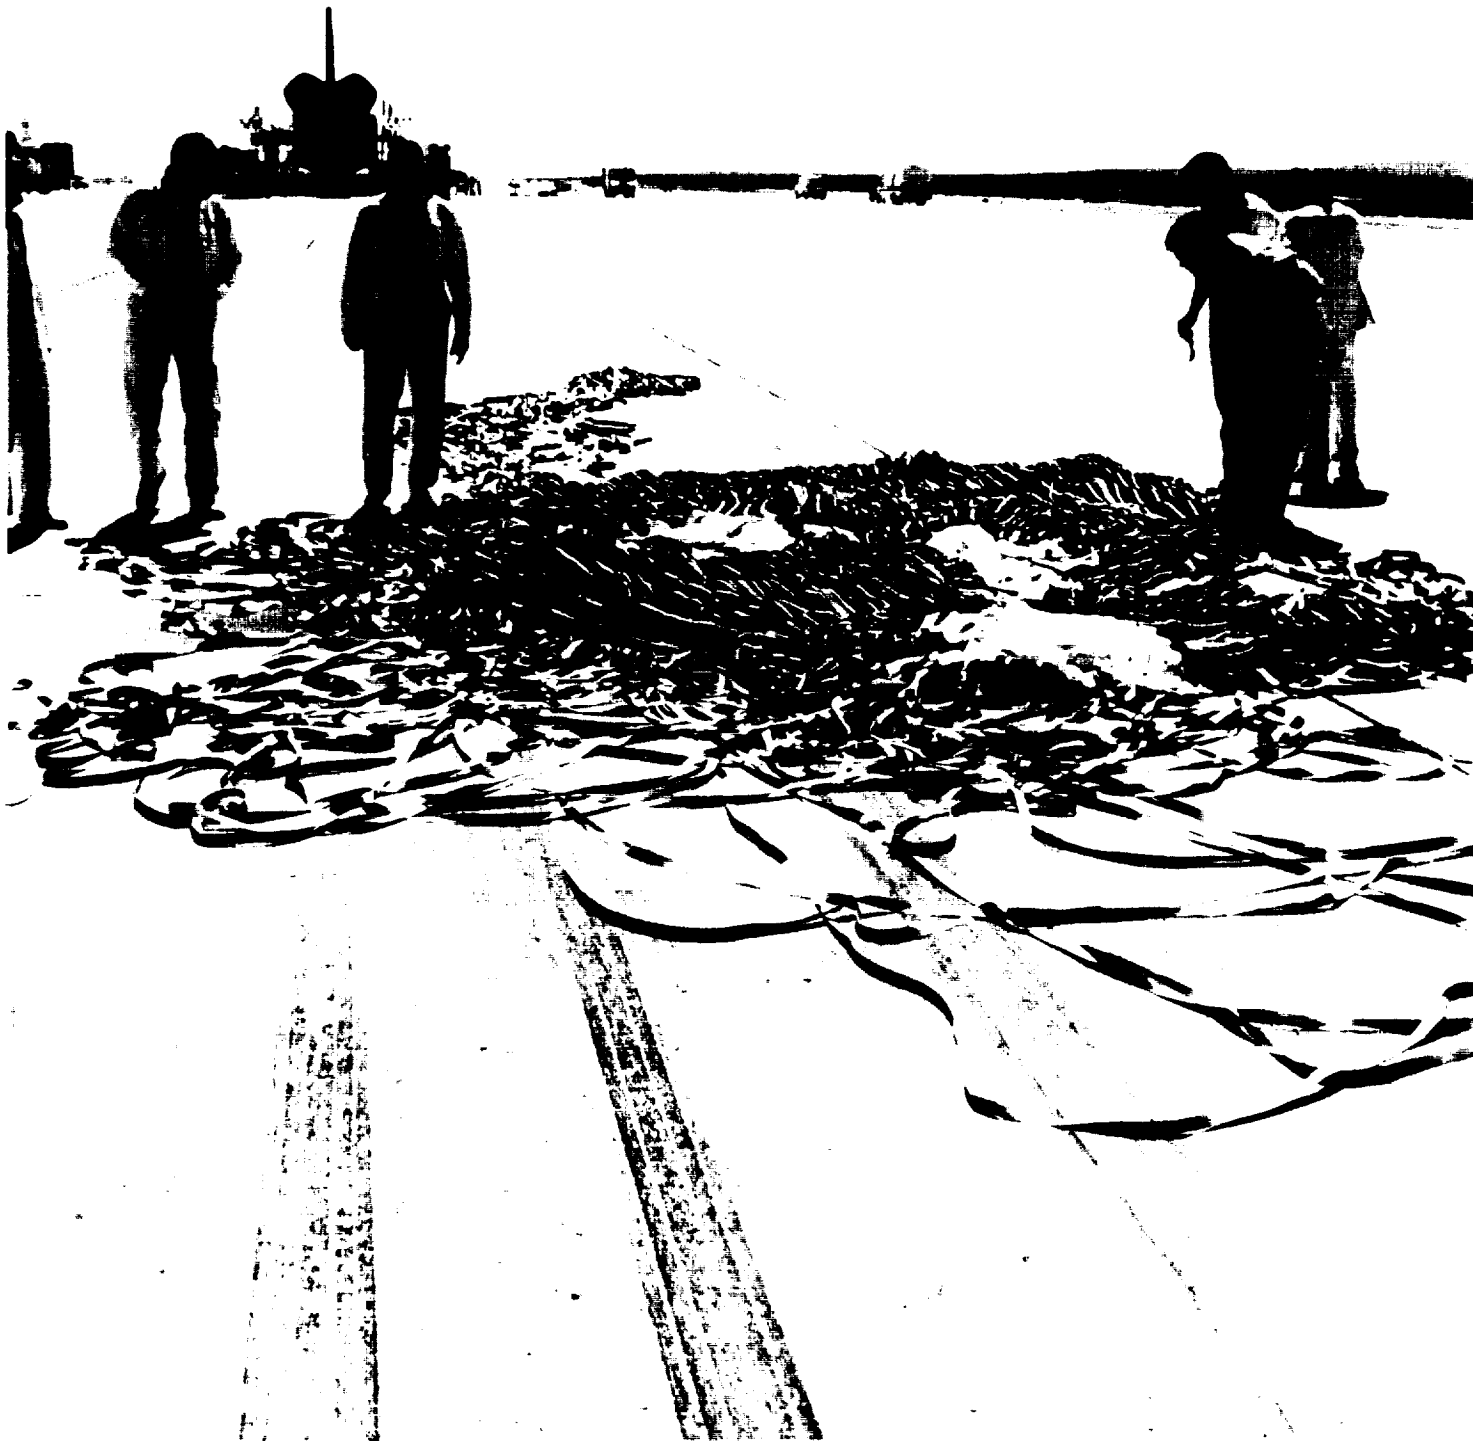
The drag chute was located approximately 750 feet aft of the Orbiter and just to the right of the centerline. All drag chute hardware was recovered and showed no anomalies.

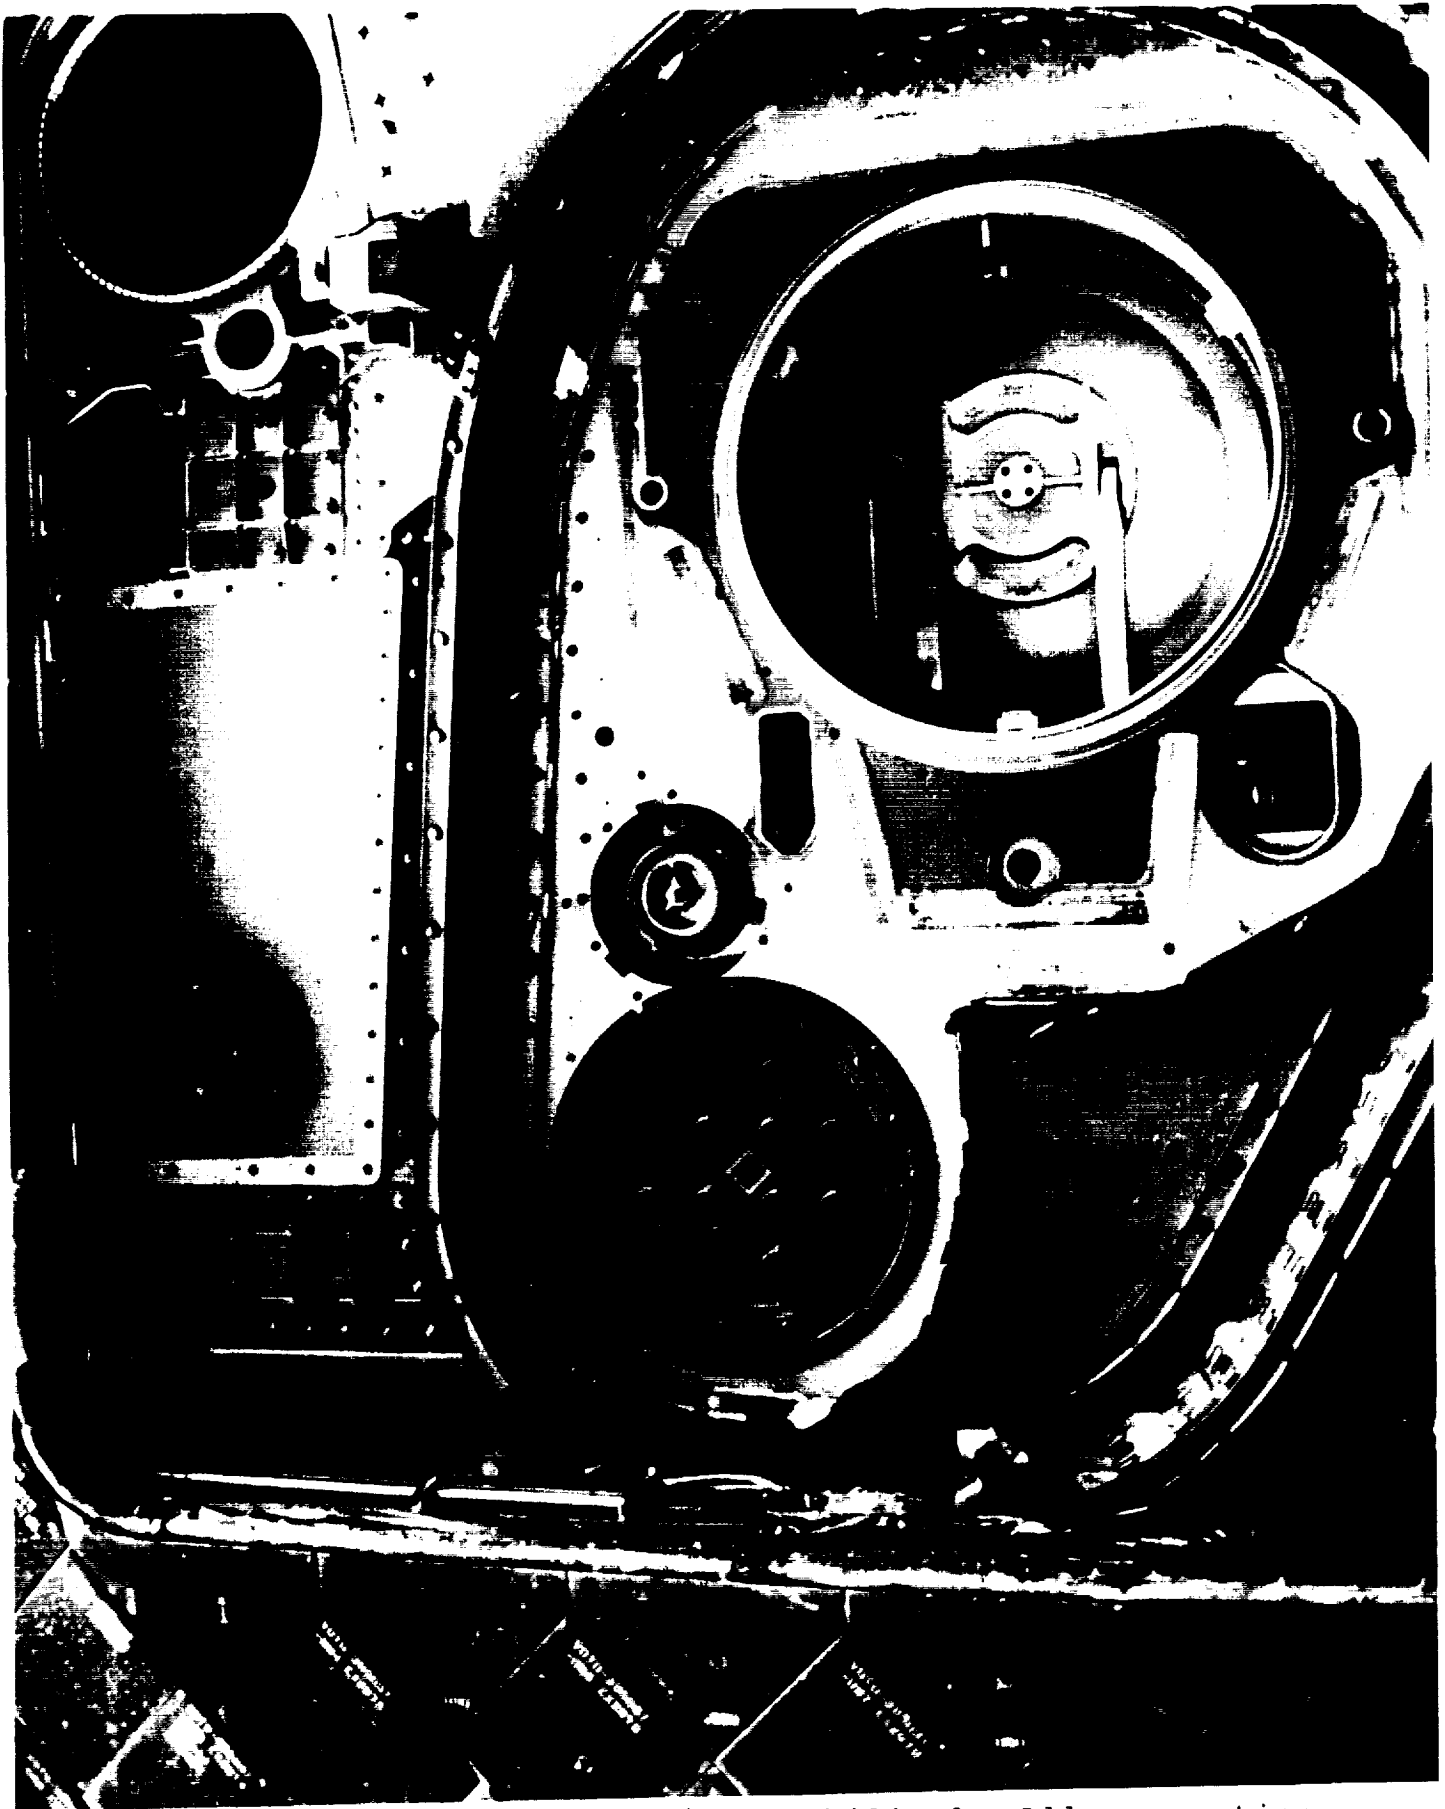
Overall view of the L02 ET/ORB umbilical. All separation ordnance devices appeared to have functioned properly.

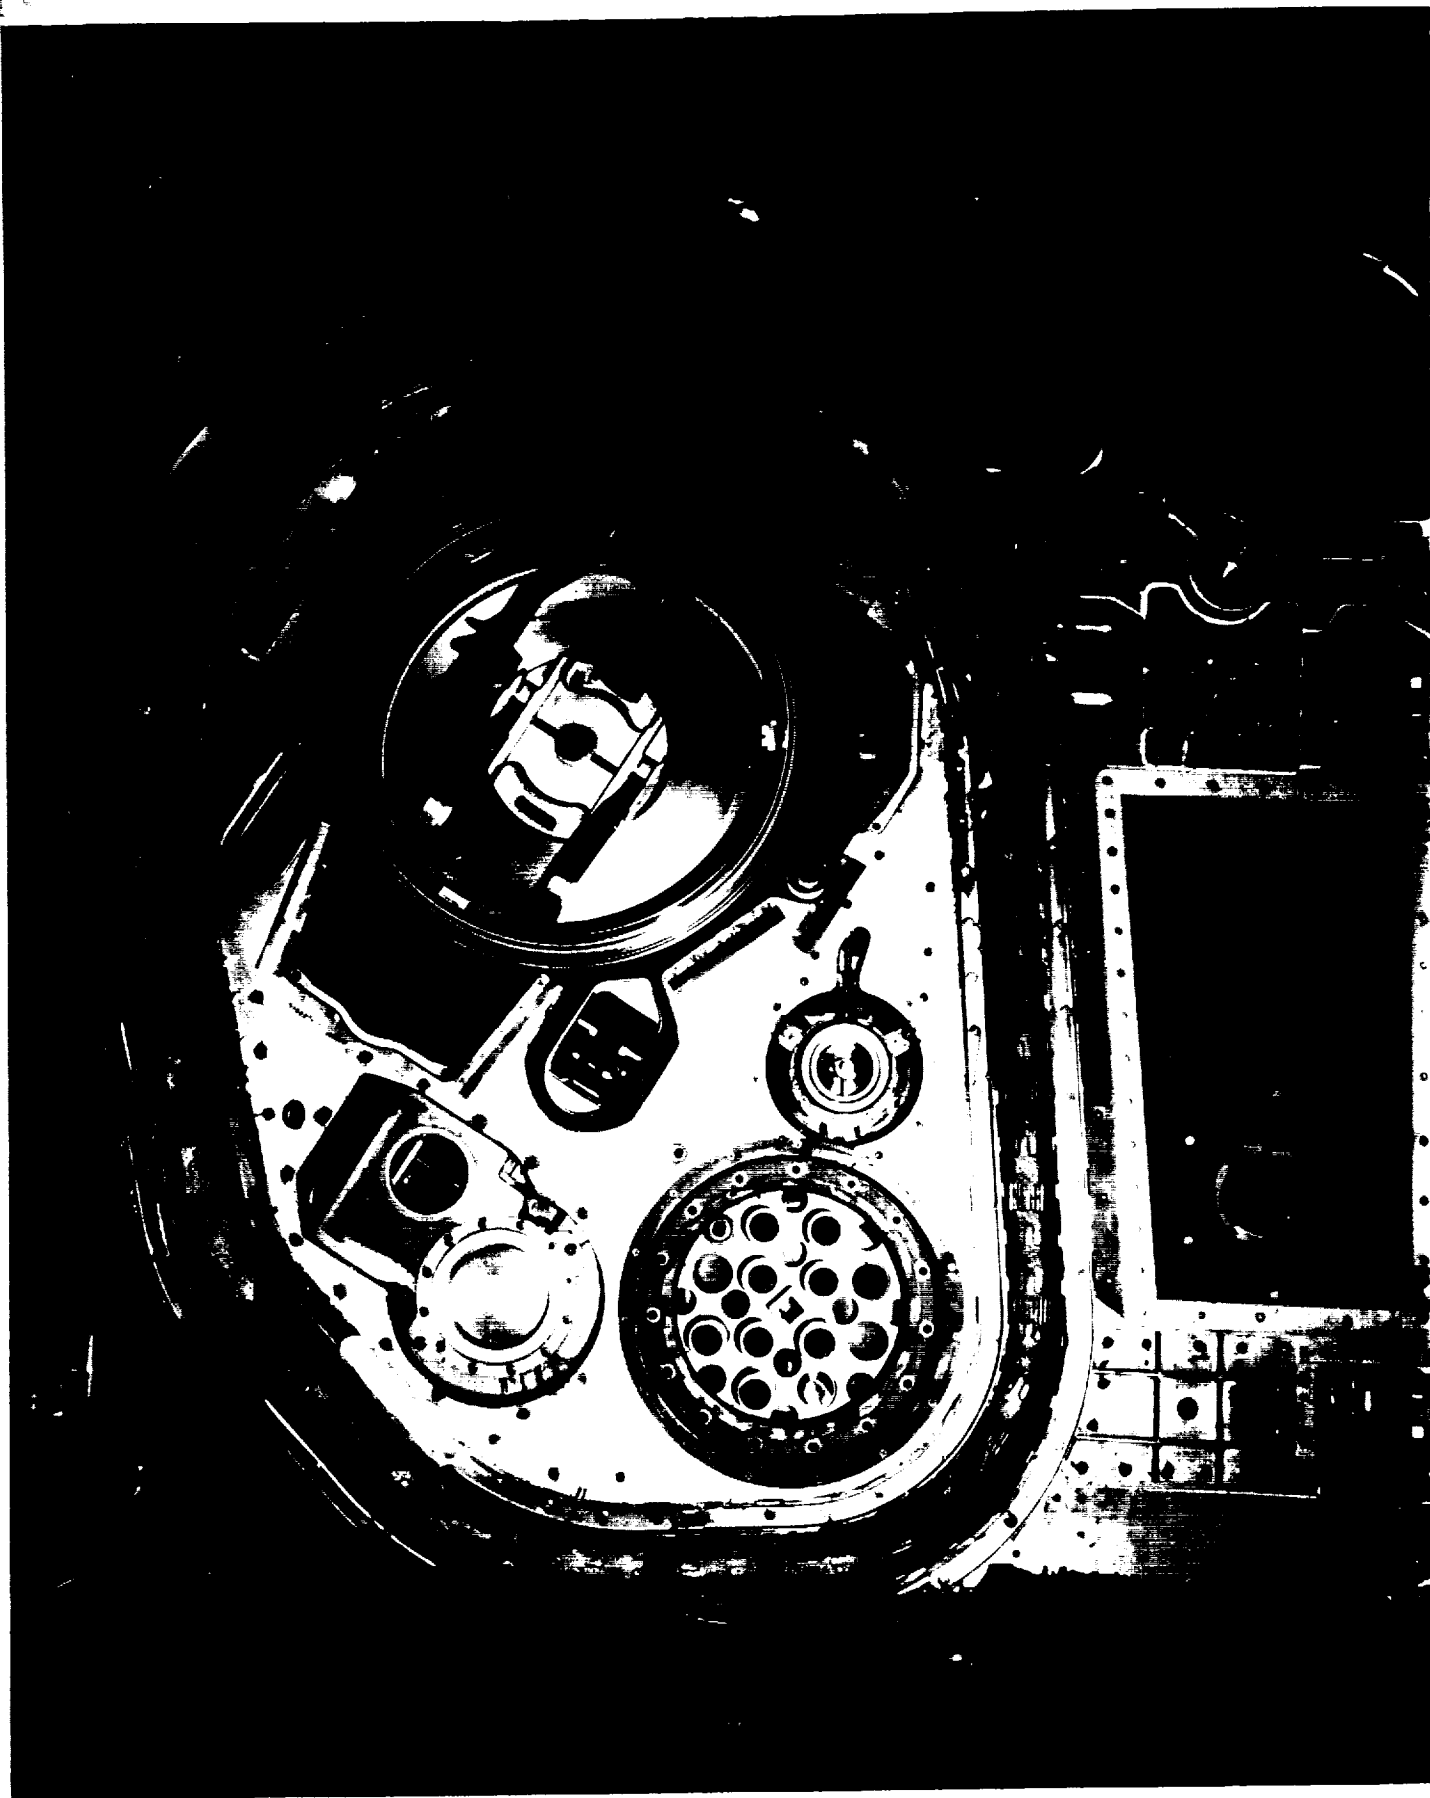
Overall view of the LH2 ET/ORB umbilical. All separation ordnance devices appeared to have functioned properly.

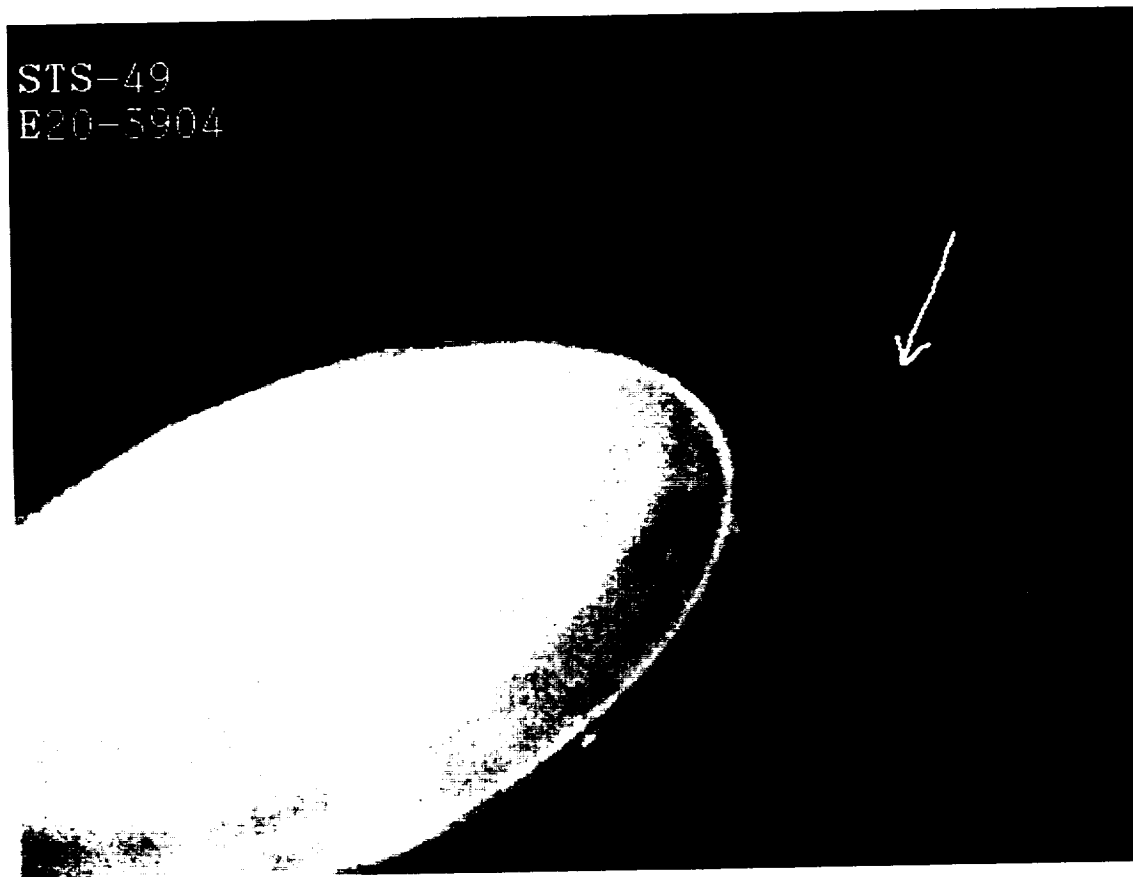
Figure 2.1.2.2 Debris near Vertical Stabilizer

A single piece of debris (dark on one side, light on the other) appeared on the right side of the FOV near the vertical stabilizer and fell aft into the SSME plume at liftoff. This debris is shown in figure 2.1.2.2. The event was shown to the TPS subsystem manager. No follow up action has been requested.

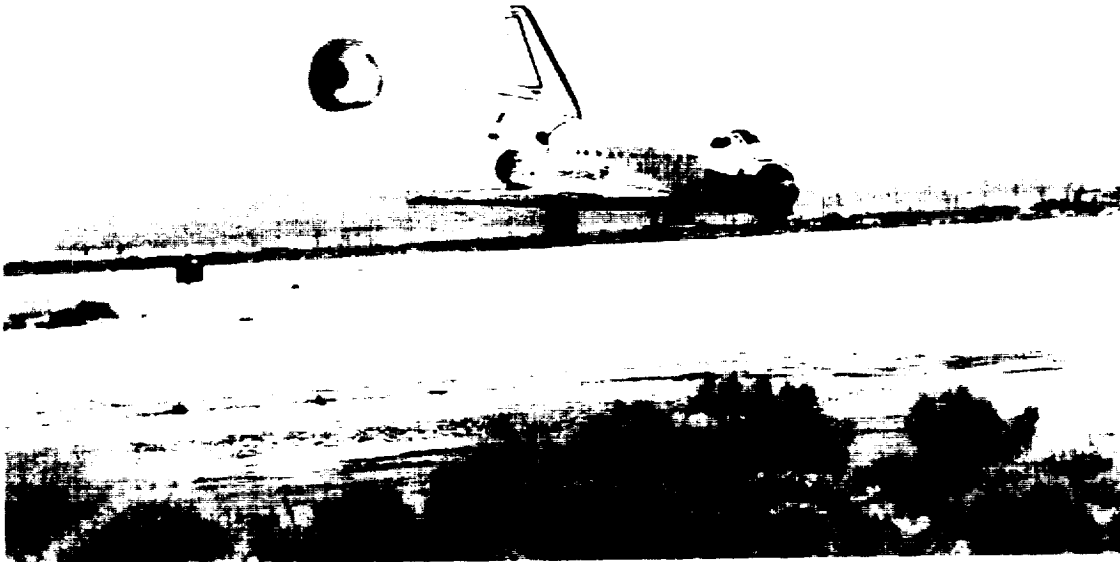
Figure 2.5.2.2 Chute Inflated in Reefed Configuration

Figure 2.5.2.2 depicts just one of many stages of the drag chute deployment. The various stages are drag chute initiation, pilot chute inflation, bag release, chute inflation in reefed configuration, disreefing initiation, full chute inflation and chute release. The analysis of the drag chute deployment and its effect upon the vehicle is still being performed as of the writing of this report and a separate report will be generated describing the results of this analysis upon completion. See Section 6.0, Appendix D, Task #10, Drag Chute Performance Analysis.
